# Manhole Inspection Summary

Manhole # S31AA2002MH

Insp Date: **4/18/07 9:30 AM**

**Location** Address: **115 CROYDON RD**

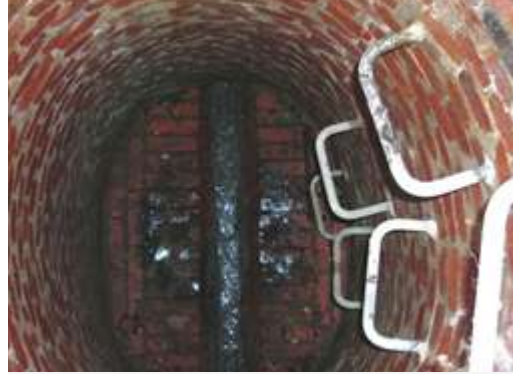
Top View

Bench debris.

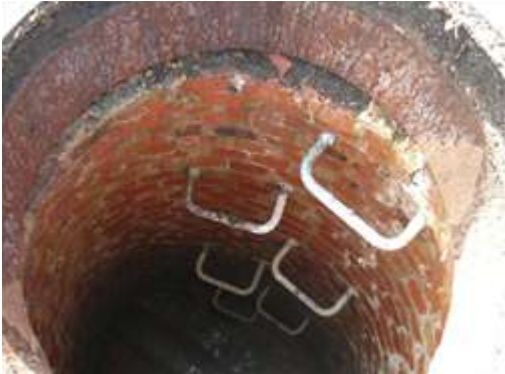
Defect

Frame leaks. Frame offset. Adjustment deterioration and infiltration. Barrel infiltration - other side.

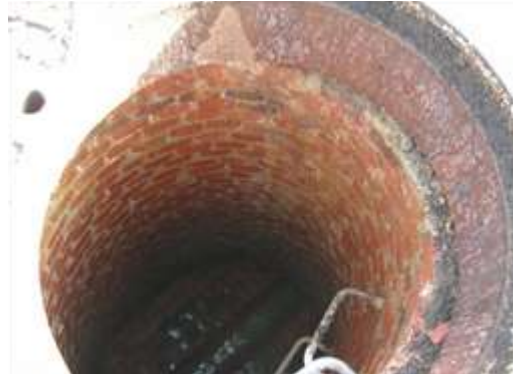
Defect

Frame leaks. Frame offset. Adjustment deterioration and infiltration. Barrel infiltration.

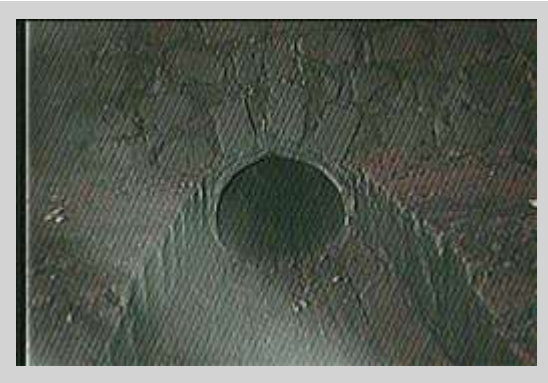
Pipe Out @ 12 O'Clock

Barrel deterioration and infiltration. Channel deterioration.

Infiltration: **Evidence** Pipe Seal Cond: **Cracked**

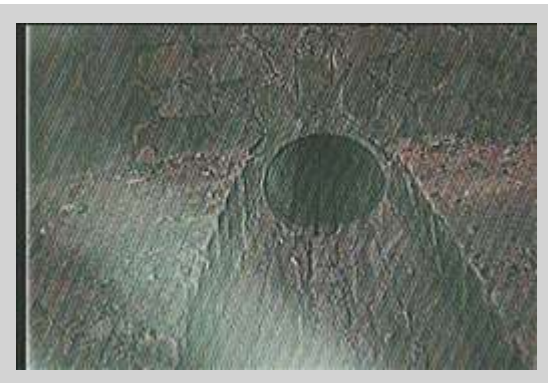
Pipe In @ 6 O'Clock

Barrel deterioration and infiltration. Channel deterioration.

Infiltration: **Evidence** Pipe Seal Cond: **Unknown**
